(NASA-CR-183585) SPACE STATION PROTECTIVE
COATING DEVELOPMENT Final Report (Boeing
Aerospace Co.) 304 p CSCL 22B

SPACE STATION PROTECTIVE COATING DEVELOPMENT

Final Report

**Contract NAS8-36586
January 1989**

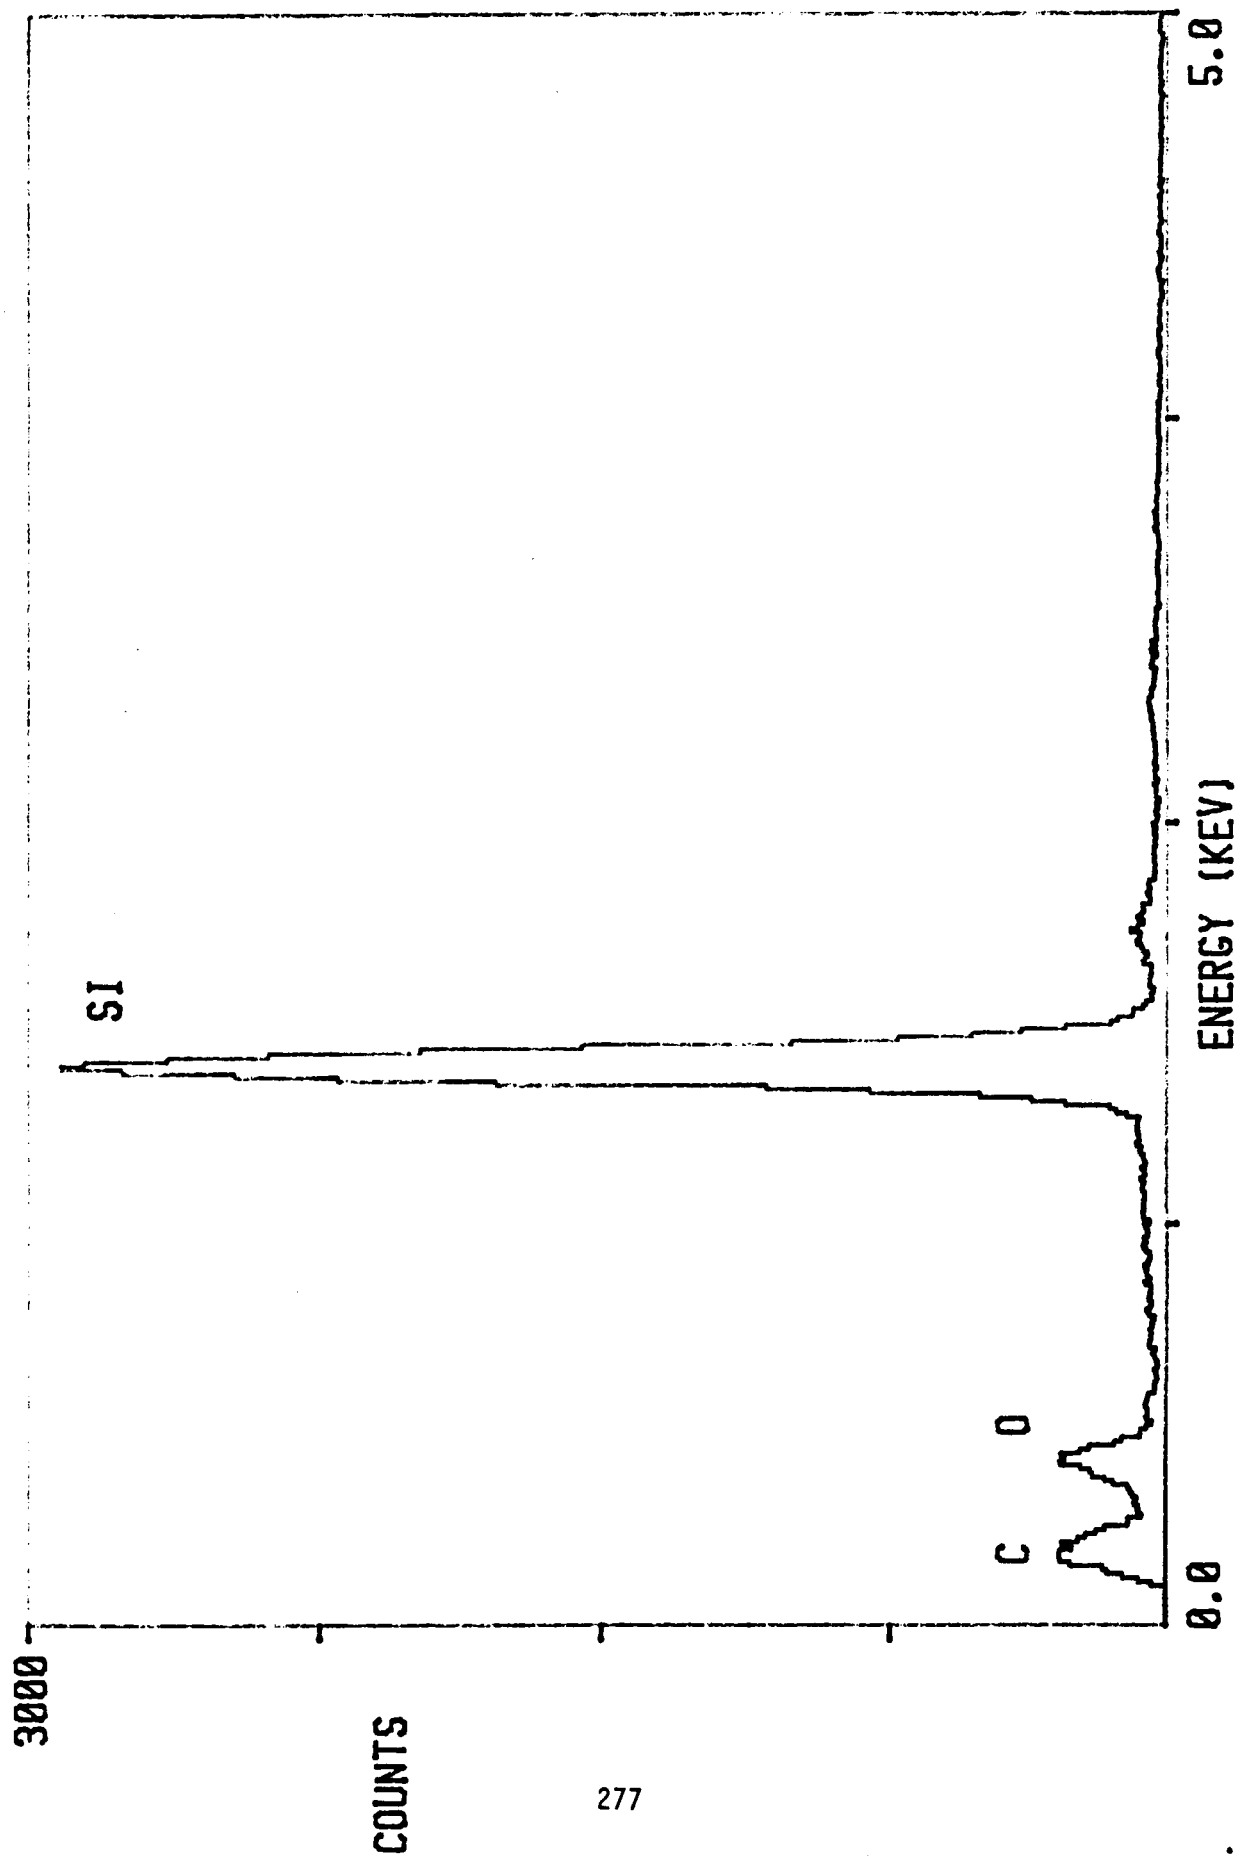
Figure 76: EDAX Spectrum of Debris on Surface of HMDS/TFE Coating

MTL-54-45-24. DEBRIS.

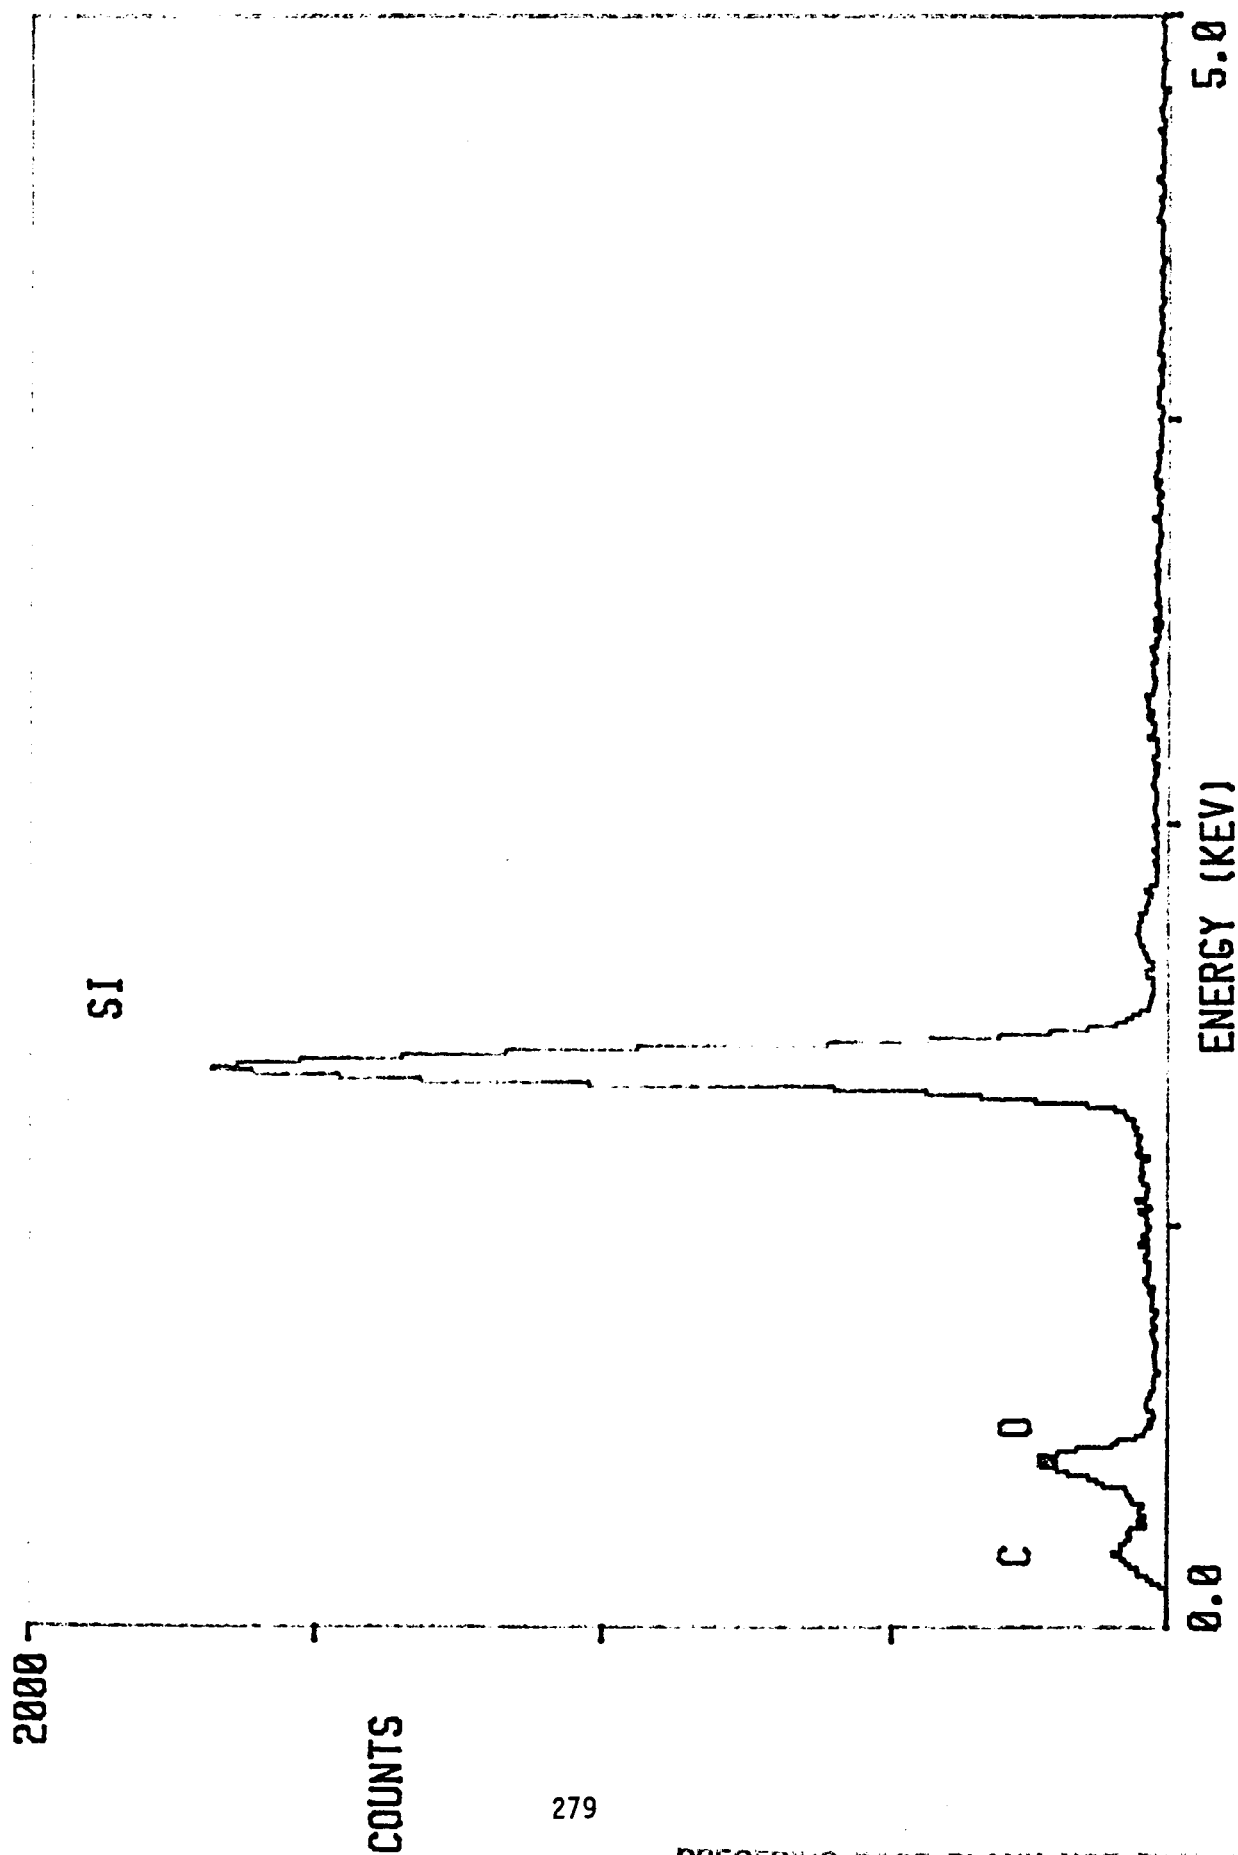
Figure 77: EDAX Spectrum of Plasma Polymerized HMDS/TFE Coating

MTL-54-45-24 X BACKGROUND.

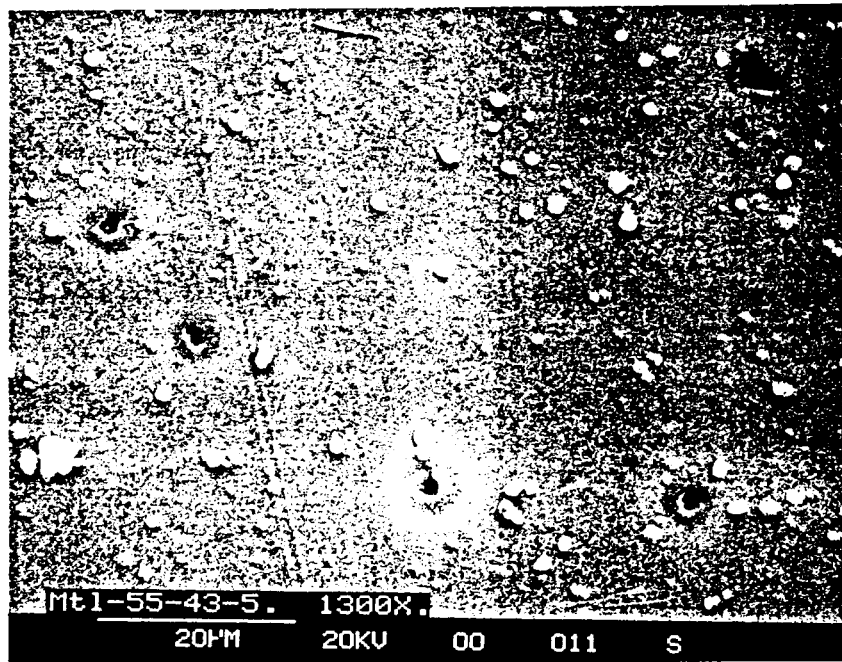
Figure 79: Plasma Polymerized HMDS/TFE Coating (#55) on 1-Mil Kapton. Sample Exposed to Atomic Oxygen Plasma for 2 Hours

Figure 79:

Title: Mtl-55-43-5. Photo #011. Magnification: 1300X. Legend: Same as for 10. Description: An area with pinhole damage. Note the more extensive damage in the lower center pit.

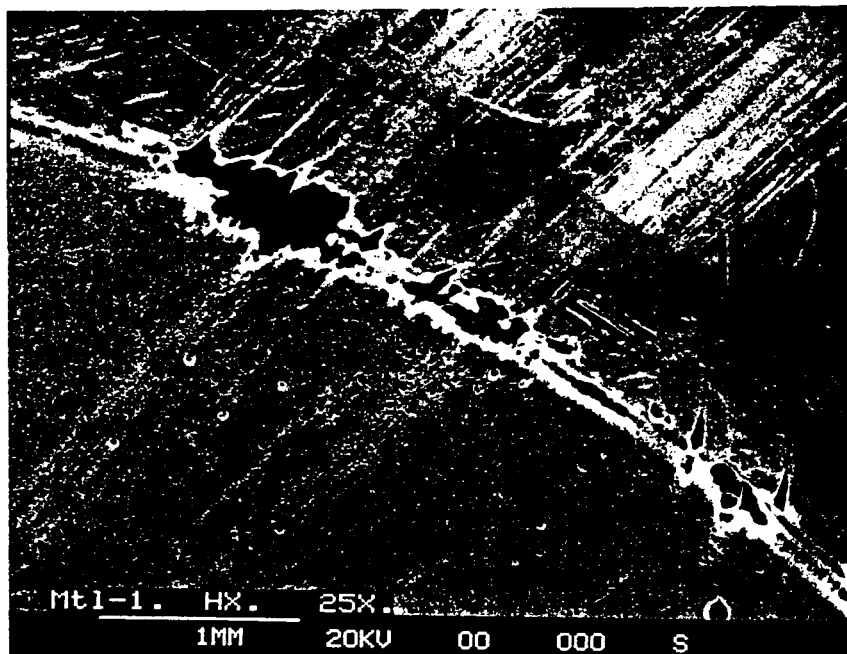
Figure 80: Kapton Film Heavily Degraded by Atomic Oxygen Exposure

Figure 80:

Title: Mtl-1. HX. Photo #000. Magnification: 25X. Legend: Rim Region of Heavily Atomic Oxygen Degraded Kapton H Film (Material #1). Description: Various degradation features at the rim region of a sample of heavily atomic oxygen - damaged Kapton film. The streaked region of pitting in the exposed area are oriented in the same direction as streaks in the rim-protected outer area (upper right). A random distribution of larger pits are visible in the exposed region. More extensive damage is seen at the former rim position, suggesting the aluminum rim lip of the sample holder acts to increase the degradation rate at this lip boundary. This may be due to mechanical stress or

damage to the sample by the metal lip.

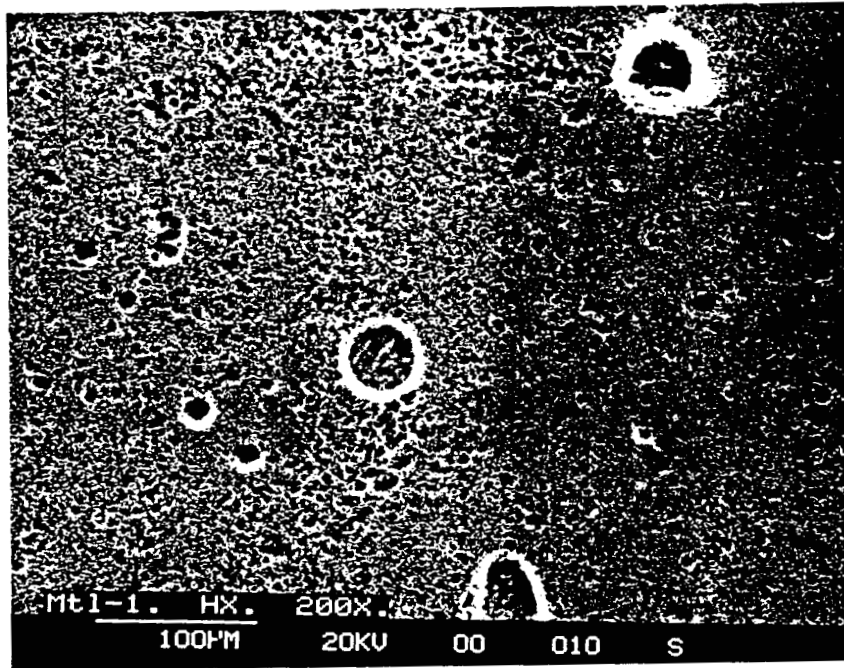
Figure 81: Kapton Film After Atomic Oxygen Exposure for 4 Hours

Figure 81:

Title: Mtl-1. HX. Photo #010. Magnification: 200X. Legend: Surface Features of Heavily Atomic Oxygen Damaged Kapton Film (Material #1). Description: A typical view at the center region of this sample.

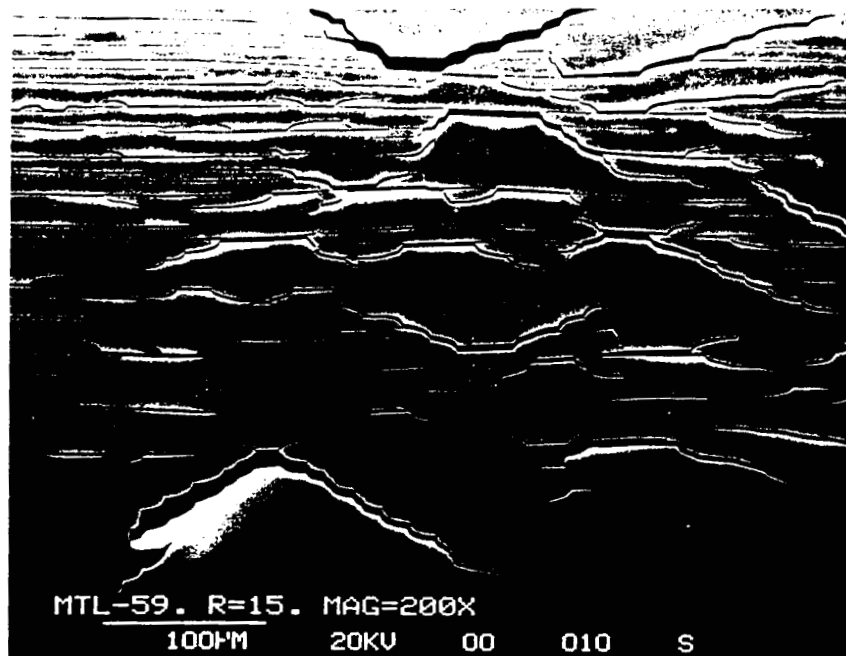
Figure 82: IITRI Glassy Silicone Bent Over a 15-Mil Radius

Figure 82:

Title: Mtl-59. R = 15. Photo #010. Magnification: 200X. Legend: Detail of

Cracking in ITTRI Glassy Silicone Coating, Over a 15 mil bend diameter (Material #59). Description: Close-up of cracking in the center of the bend region. There is extensive lateral cracking, with some diagonal cracking and coating delamination.

The "bend radius" testing of candidate coating materials on Kapton polyimide film substrate was accomplished by taping strips of the coated film over a rounded metal edge of a known diameter (thickness). The diameters used were 15 and 40 mils. The strips, fastened to the metal sample mount, were then sputter coated with gold/palladium for examination under the scanning electron microscope (SEM). The specimens were examined for evidence of cracking of the coating in the bend region. The specimens were viewed edge-on to the bend region at a 0 to 20 degree angle to the SEM electron beam. The specimens (5-8mm wide by 20-40mm long) were cut from as-received sheet stock, one end of a strip attached to one side of the sample mount by double-backed adhesive tape, and the specimen bent over the rounded edge of the mount and fastened on the other side of the mount with tape. A minimum of tensile force was applied to the specimen as it was bent over the rounded edge. Two to three separate specimens could be placed on each sample mount. The mounted specimens were then coated with gold/palladium, and fastened to an SEM sample stub for mounting in the SEM sample chamber.

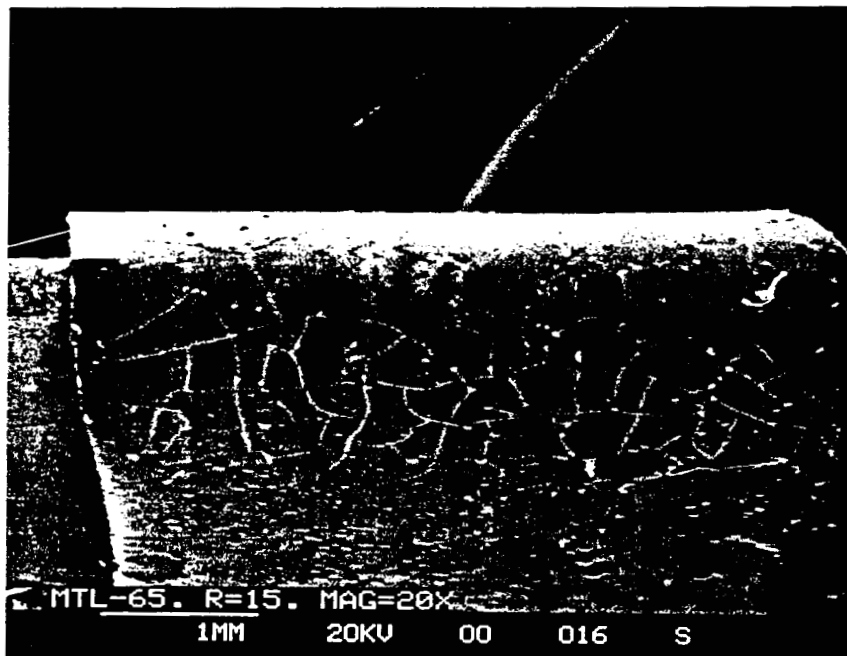
Figure 88: CVI-1144-0 Siloxane Coating (#65) on Kapton Bent Over a 15-Mil Radius

Figure 88:

Title Mtl-65. R = 15. Photo #016. Magnification: 20X. Legend: Bend Region with Cracks Visible in McGhan-NuSil CV1-1144-0 Silicone Coating, Over a 15 mil Bend Diameter (Material #65). Description: A view of the entire bend region of this specimen, showing extensive cracking. Comparing this photo to photo #012, the cracking here is more random in orientation.

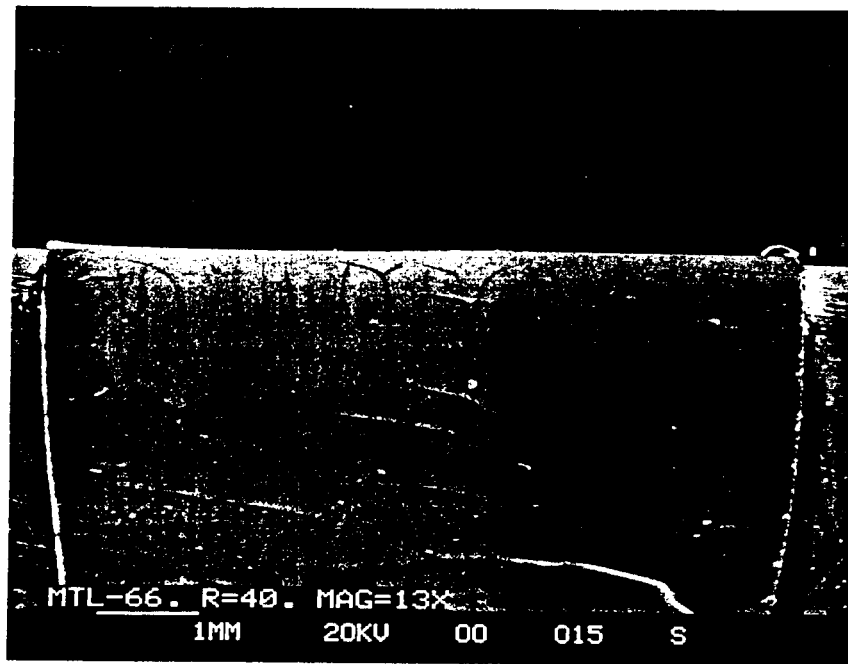
Figure 89: CVI-3530 Fluorosilicone Coating (#66) on Kapton Bent Over a 40-Mil Radius

Figure 89:

Title: Mtl-66. R = 40. Photo #015. Magnification: 13X. Legend: Bend Region of McGhan-NuSil CV1-3530 Fluorosilicone Coating, Over a 40 mil Bend

Diameter (Material #66). Description: Extensive cracking is clearly visible over the entire bend region and down the sides of the specimen.

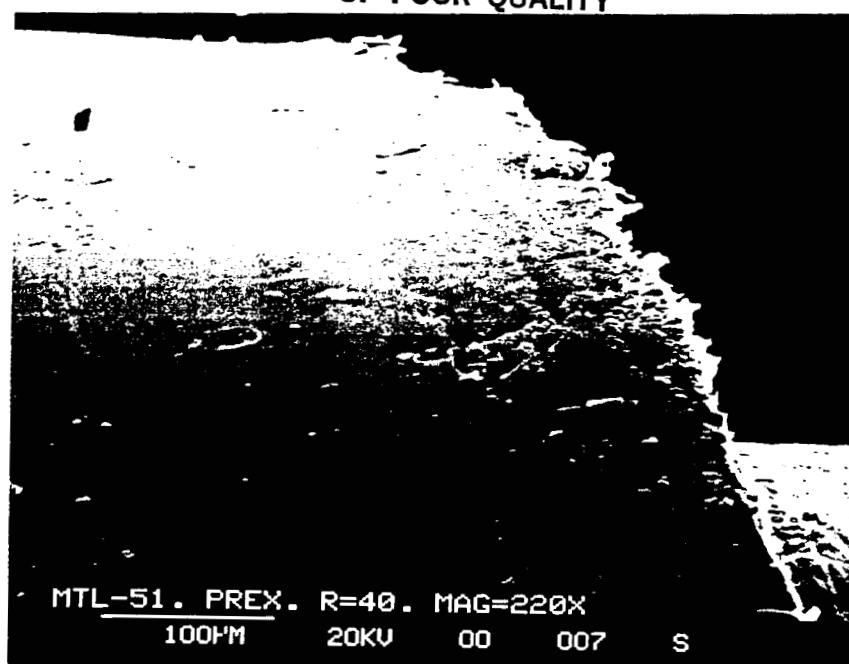
Figure 93: Plasma Polymerized HMDS/TFE Coating (#51) on Kapton Bent
Over a 40-Mil Radius

Figure 93:

Title: Mtl-51. R = 40. Photo #007. Magnification: 200X. Legend: Edge of

Bend Region of Battelle Plasma Polymerized HMDS/TFE (Ratio 20/1) Coating, Over a 40 mil Bend Diameter (Material #51). Description: No cracking was observed in this sample. This is a view of the edge of the bend region, showing damage caused by cutting the sample from sheet stock.

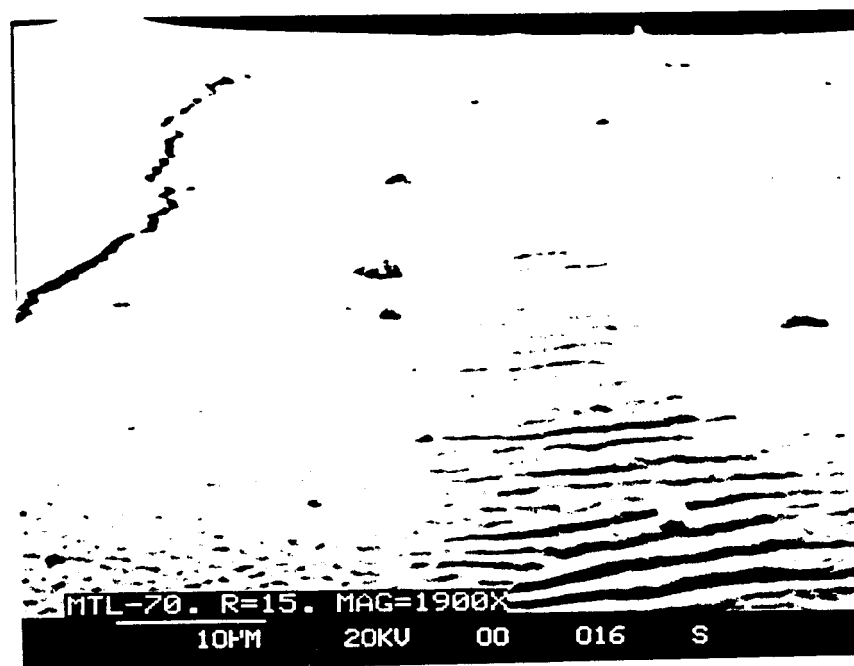
Figure 96: CVI-3530 Fluorosilicone Coating (#70) on Kapton Bent Over 15-Mil Radius

Figure 96:

Title: Mtl-70. R = 15. Photo #016. Magnification: 1900X. Legend: Crack and Unusual Surface Features of McGhan-NuSIL CV1-3530 Fluorosilicone Coating, Over a 15 mil Bend Diameter (Material #70). Description: Wide areas of

parallel grooves or ridges were observed in places on this sample. Note rough crack to upper left.

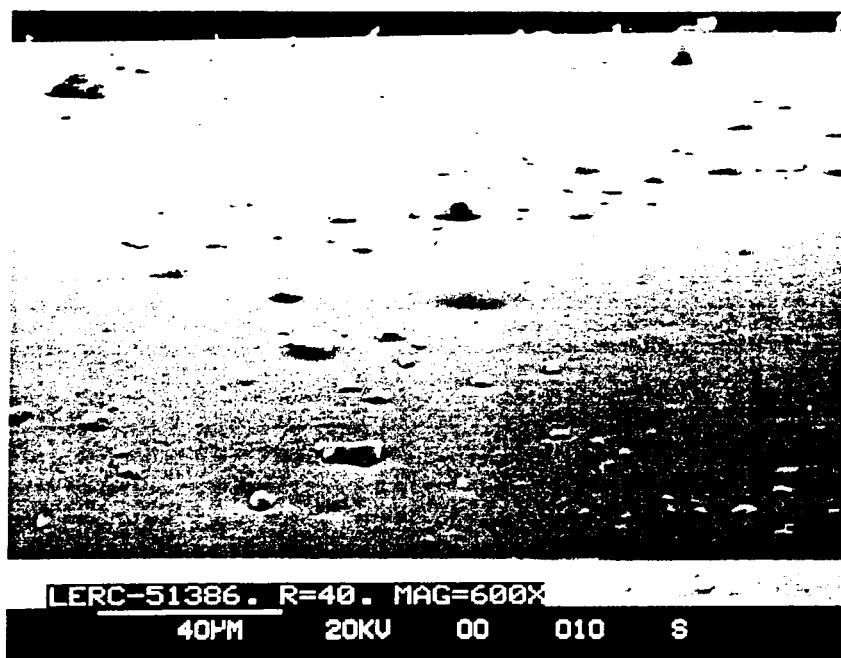
Figure 99: LeRC Siloxane Coating on Kapton Bent Over 40-Mil Radius

Figure 99:

Title: LERC-51386. R = 40. Photo #010. Magnification: 600X. Legend: Bend Region of NASA-LeRC Siloxane (SiO) Coating, Over a 40 mil Bend Diameter (Material #LERC-51386). Description: No cracking was observed in this sample. This is a typical view of the bend region surface.

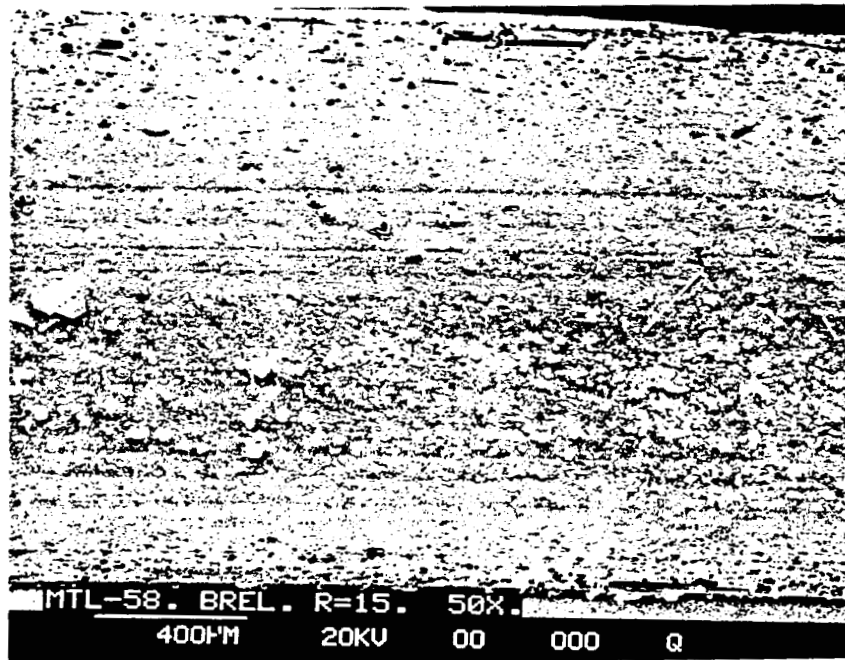
Figure 101: X-128 Coating (#58) on Kapton Bent Over 15-Mil Radius. Sample Previously Exposed to Combined Vacuum Thermal Cycling/UV Radiation

Material #58: Ethyl X-128 fluorophosphazene coating on 1 mil Kapton film;

BREL test #1; Au/Pd-coated for SEM analysis.

Figure 101:

Title: Mtl-58. BREL. R = 15 ("R" = bend diameter in mils). Photo #000. Magnification: 50X. Legend: Bend Region of Vacuum Cycled sample, Over a 15 mil Bend Diameter (Material #58). Description: No cracking was observed over the bend region of this sample. The streaks/lines seen in this photo are due to an auto-tracking contrast function on the SEM, which was used to adjust for widely varying contrast levels across the sample; the lines are artifacts of the SEM, and not physical features on the coating surface. EDAX analysis of virgin and BREL-tested (figure 103) Material #58 indicates a slight loss of O, F, Al and Si upon Brel testing. This may indicate some loss of fluoroalkyl side groups from the material surface, possibly by UV-induced P-O bond disruption.

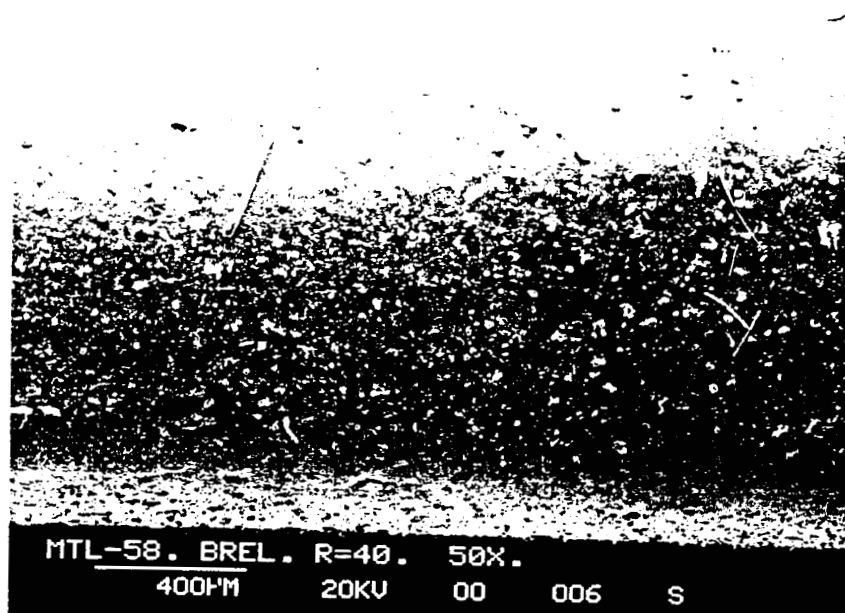
Figure 102: X-128 Coating (#58) on Kapton Bent Over 15-Mil Radius. Sample Previously Exposed to Combined Vacuum Thermal Cycling/UV Radiation

Figure 102:

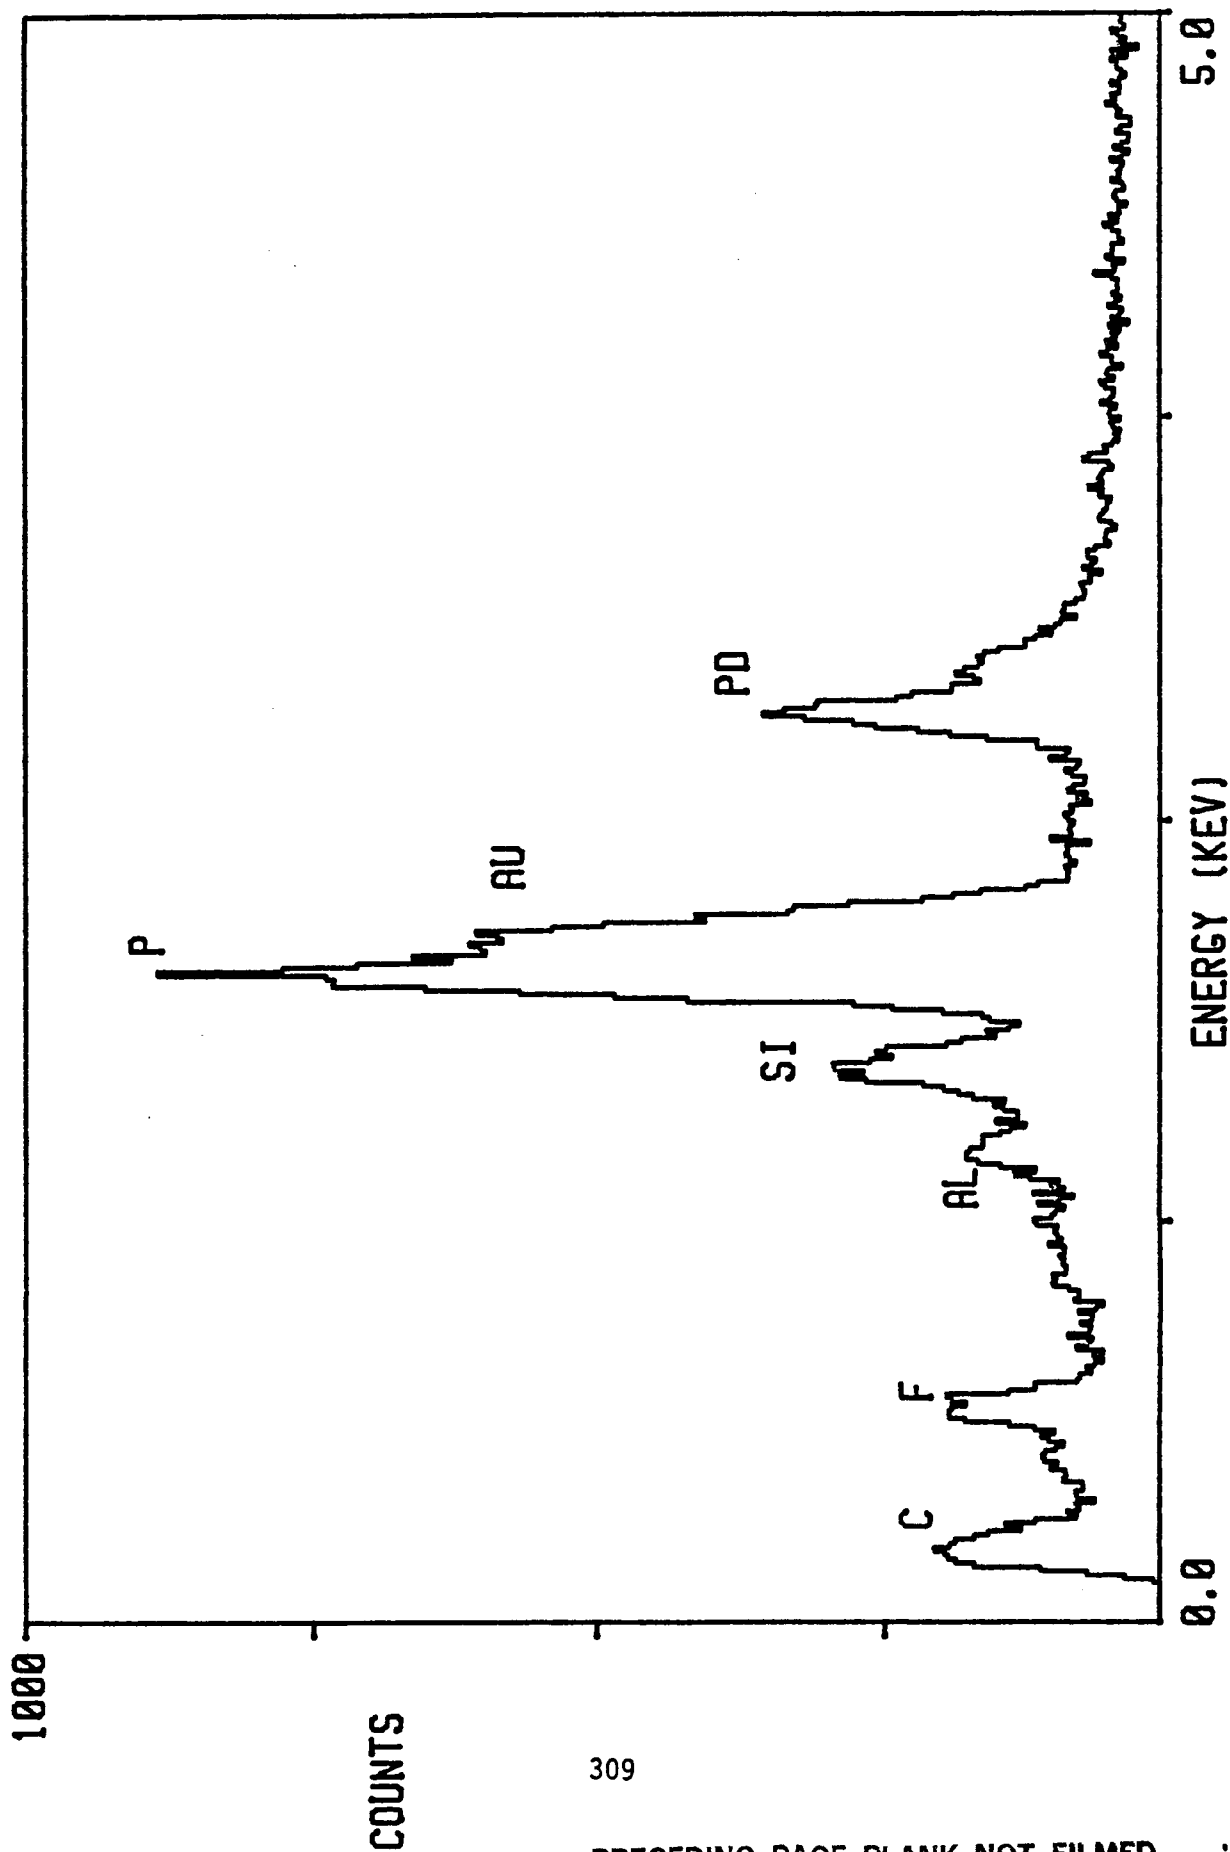
MTL-58. BREL.

Figure 103: EDAX Spectrum of X-128 Coating. Sample Was Previously Exposed to Combined Vacuum Thermal Cycling/UV Radiation

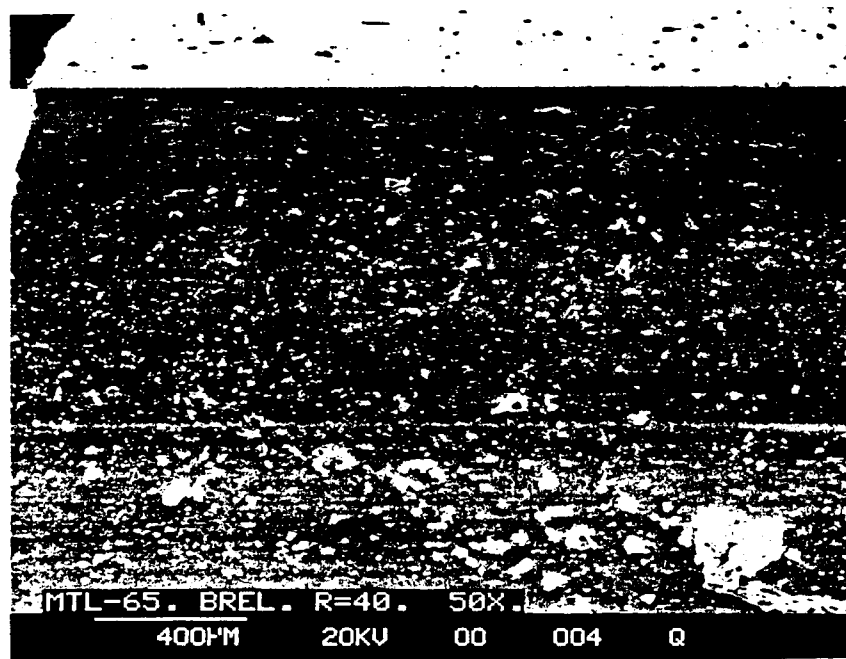
Title: Mtl-65. BREL. R = 40. Photo #004. Magnification: 50X. Legend: Same as above, except over a 40 mil bend diameter. Description: No cracks were observed in the surface of this coating, while cracking was extensive in the virgin material. The lateral lines in this photo are due to the SEM auto-track function, and are not real physical features.

Figure 105: CV1-1144-0 Silicone Coating (#65) on Kapton Bent Over 15-Mil Radius. Sample Previously Exposed to Combined Vacuum Thermal Cycling/UV Radiation.

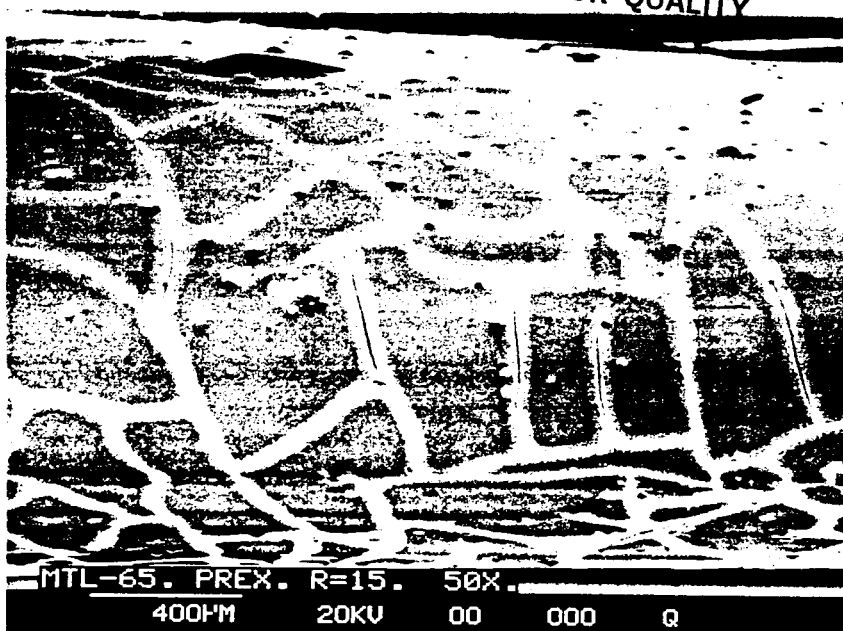
Title: Mtl-65. PREX. R = 15. Photo #002. The photo is incorrectly labeled as photo #000). Magnification: 50X. Legend. Cracks in Surface of As-Received McGhan-NuSil CV1-1144-0 Silicone Coating, Over a 15 mil Bend Diameter (Material #65). Description: Cracks as seen in this photo were observed over the entire bend region. EDAX analysis indicates an increase in C, O and Al, and a decrease in Si upon BREL testing. These EDAX spectra are shown in figures 108 and 109.

Figure 106: CVI-1144-0 Siloxane Coating (#65) on Kapton Bent Over a 15-Mil Radius

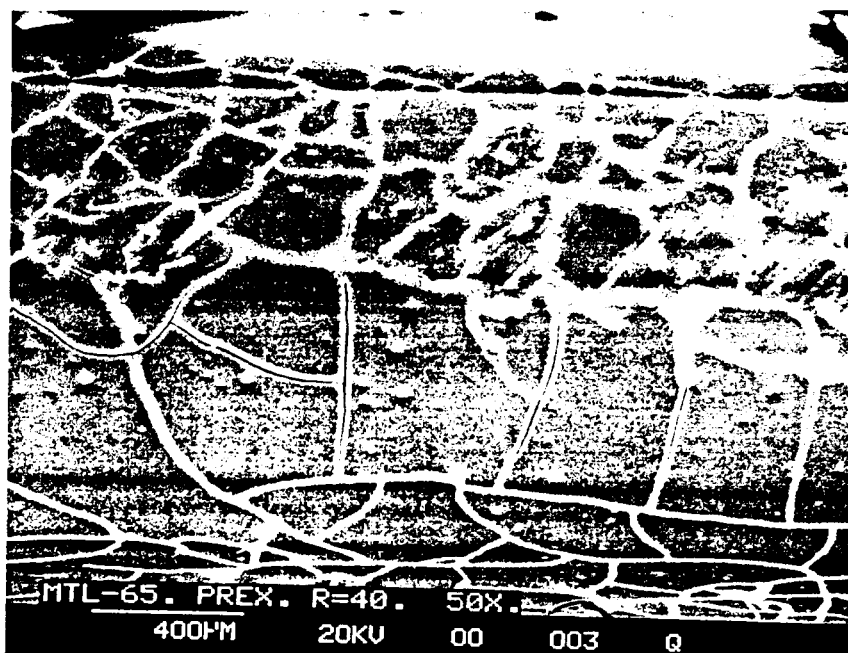
Title: Mtl-65. PREX. R = 40. Photo #003. Magnification: 50X. Legend: Same as above, except over a 40 mil bend diameter. Description: Cracks as seen in this photo were observed over the entire bend region.

Figure 107: CVI-1144-0 Siloxane Coating (#65) on Kapton Bent Over a 40-Mil Radius

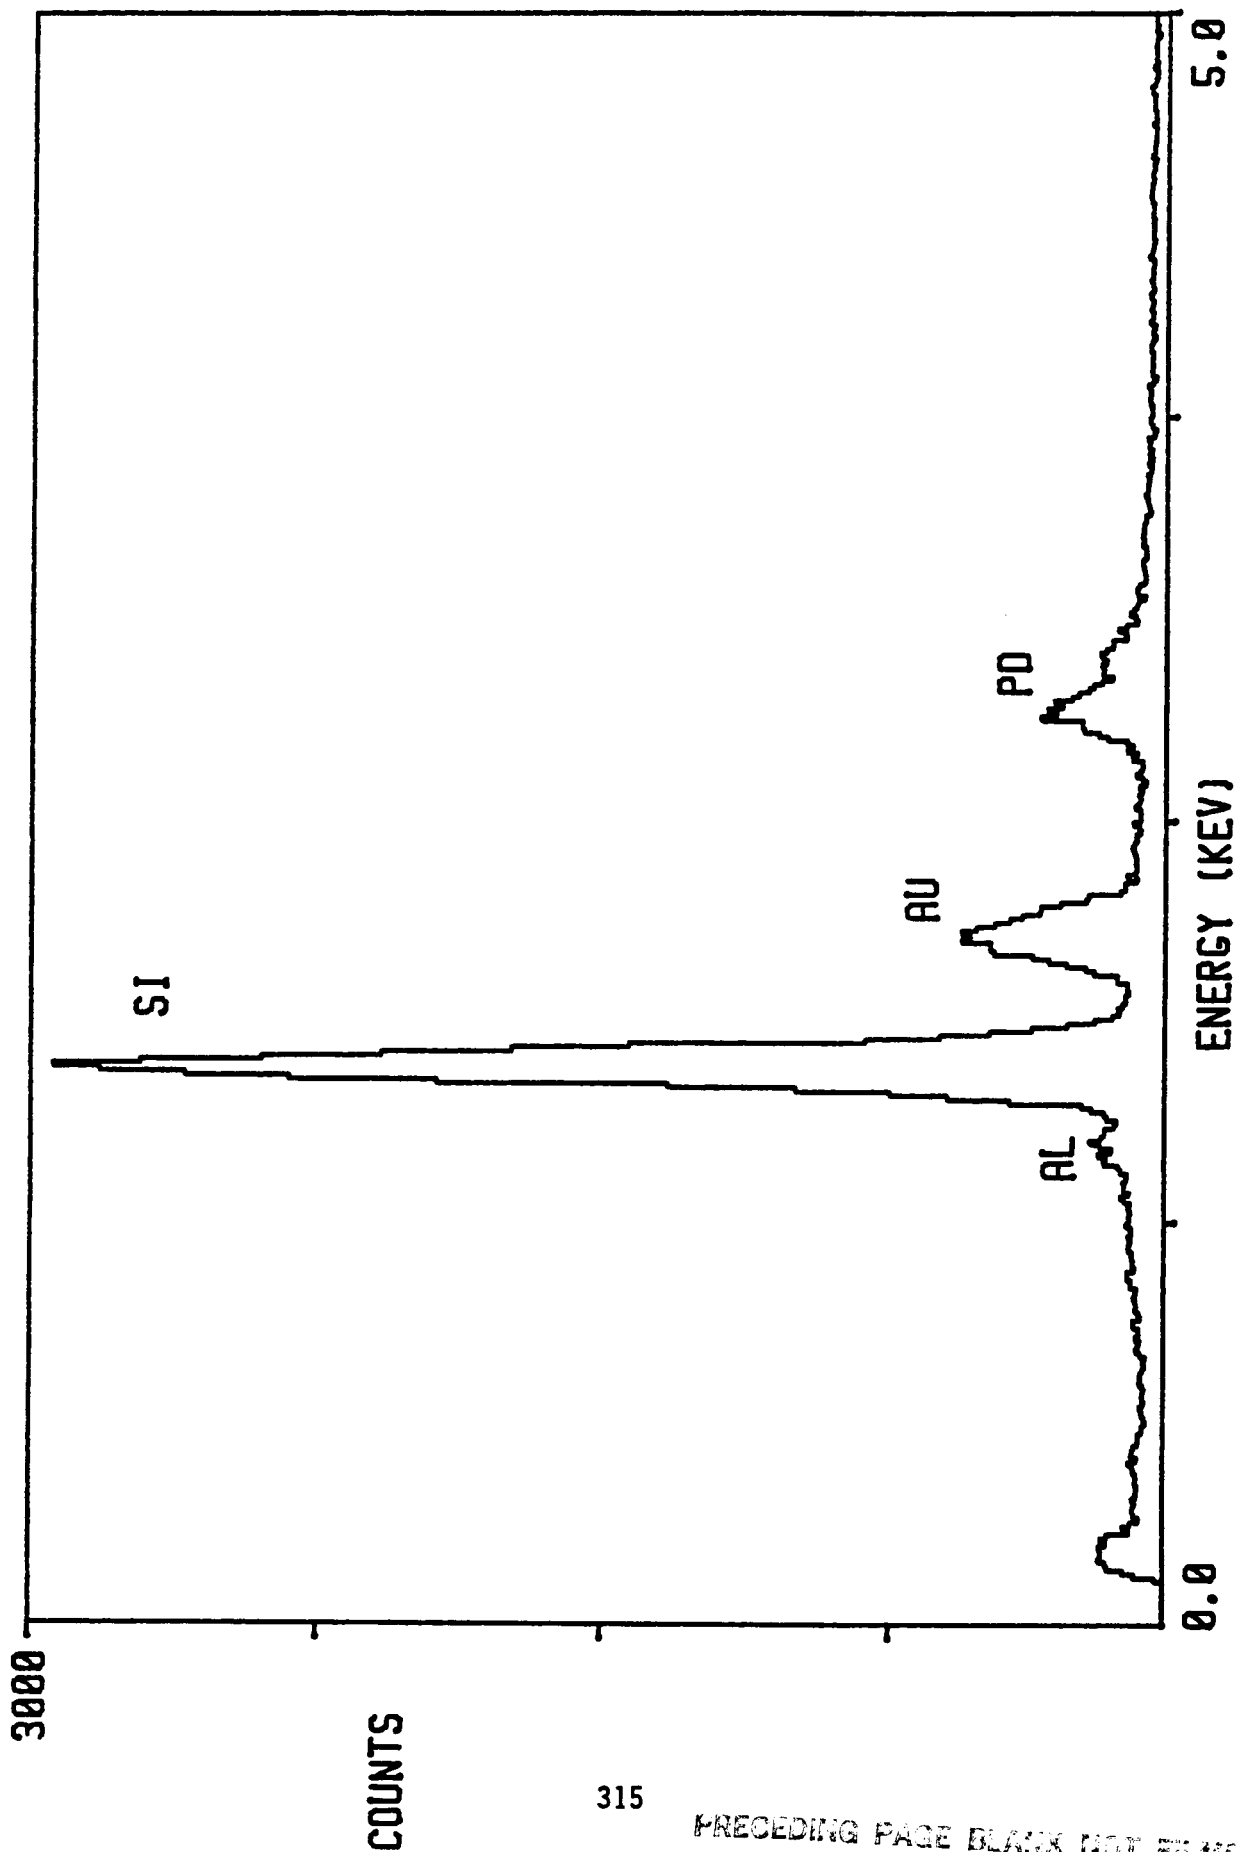
MTL-65. PREX.

Figure 108: EDAX Spectrum of CVI-1144-0 Siloxane Coating on Kapton

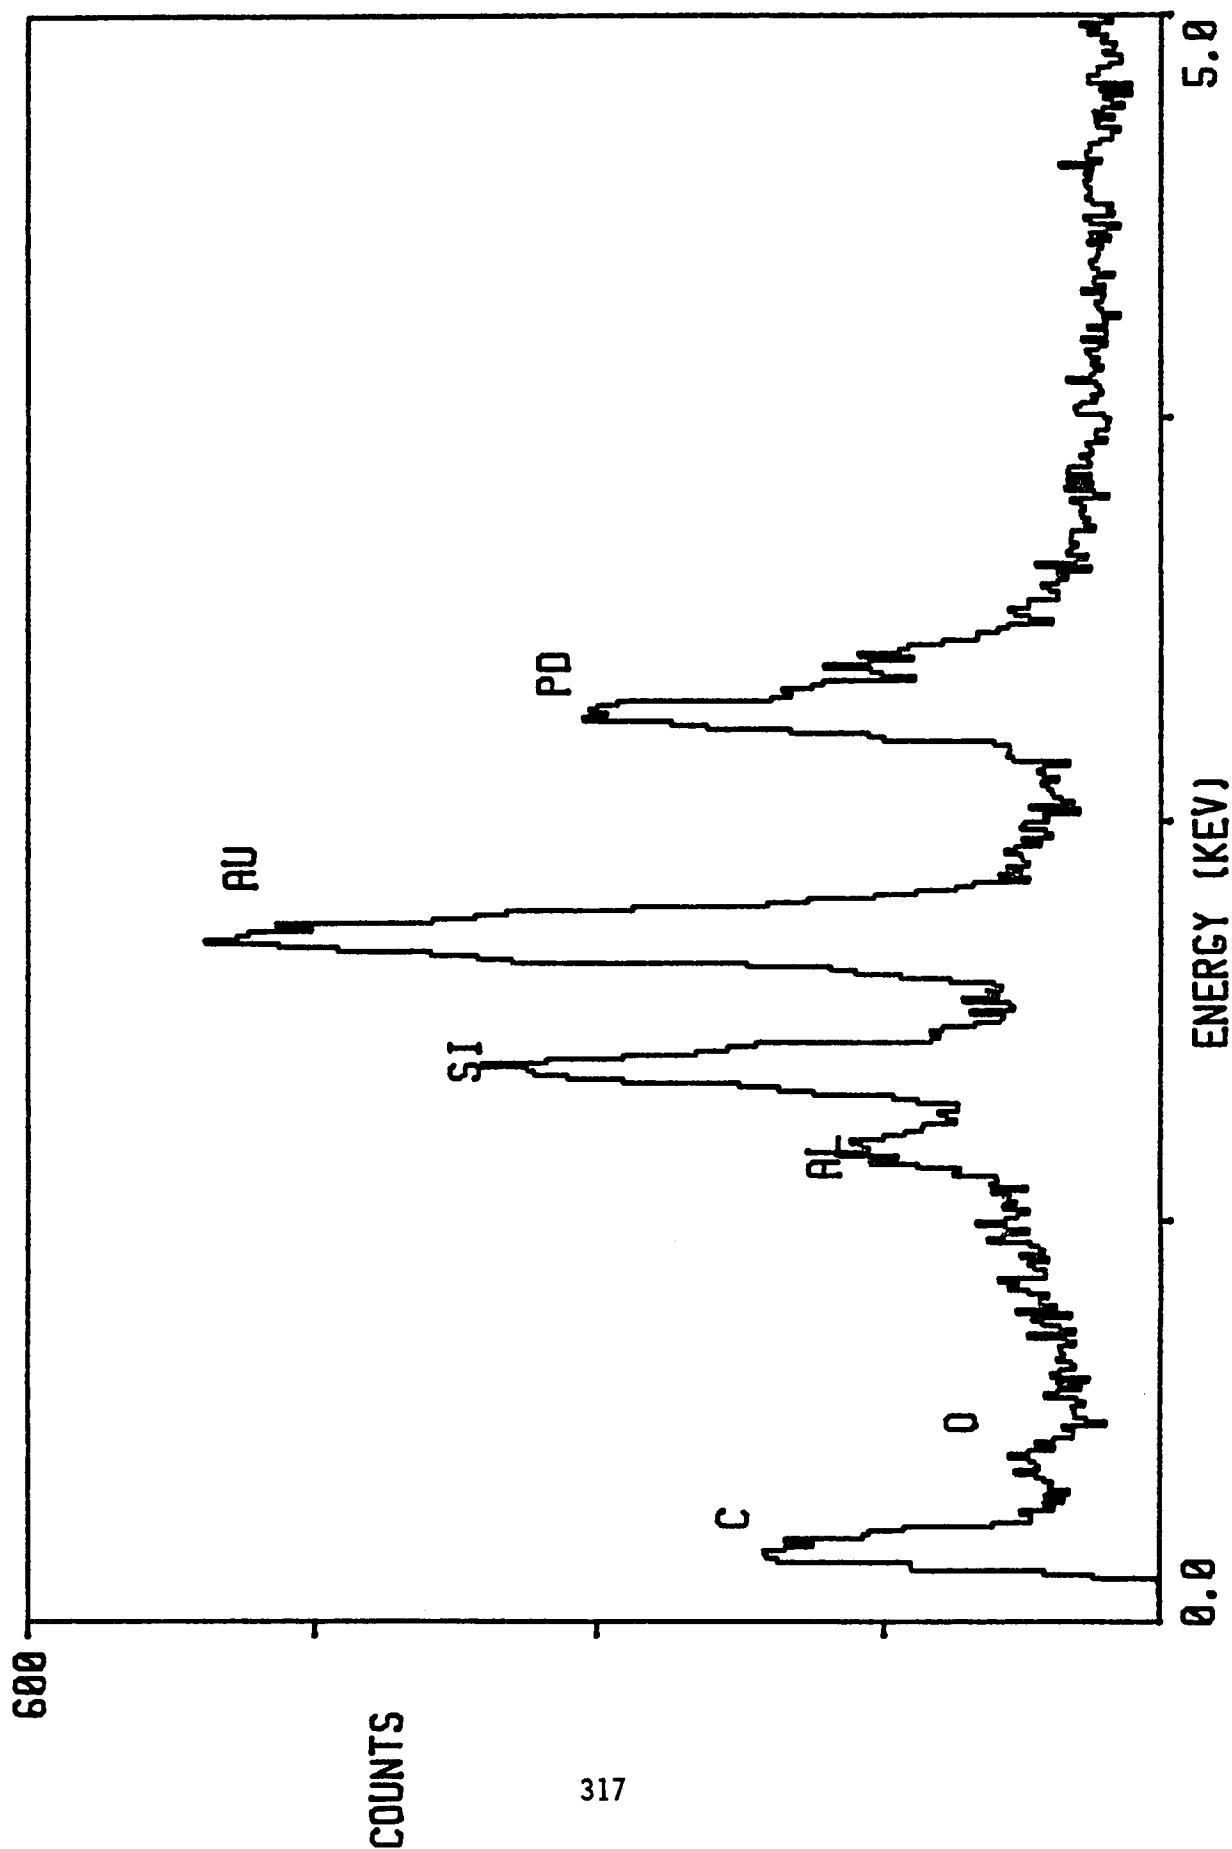
MTL-65. BREL.

Figure 109: EDAX Spectrum of CVI-1144-0 Siloxane Coating on Kapton Sample Previously Exposed to Combined Vacuum Thermal Cycling/UV Radiation
